Thematic Survey of Oklahoma Sandstone Canals

Survey Report

August 12, 2022

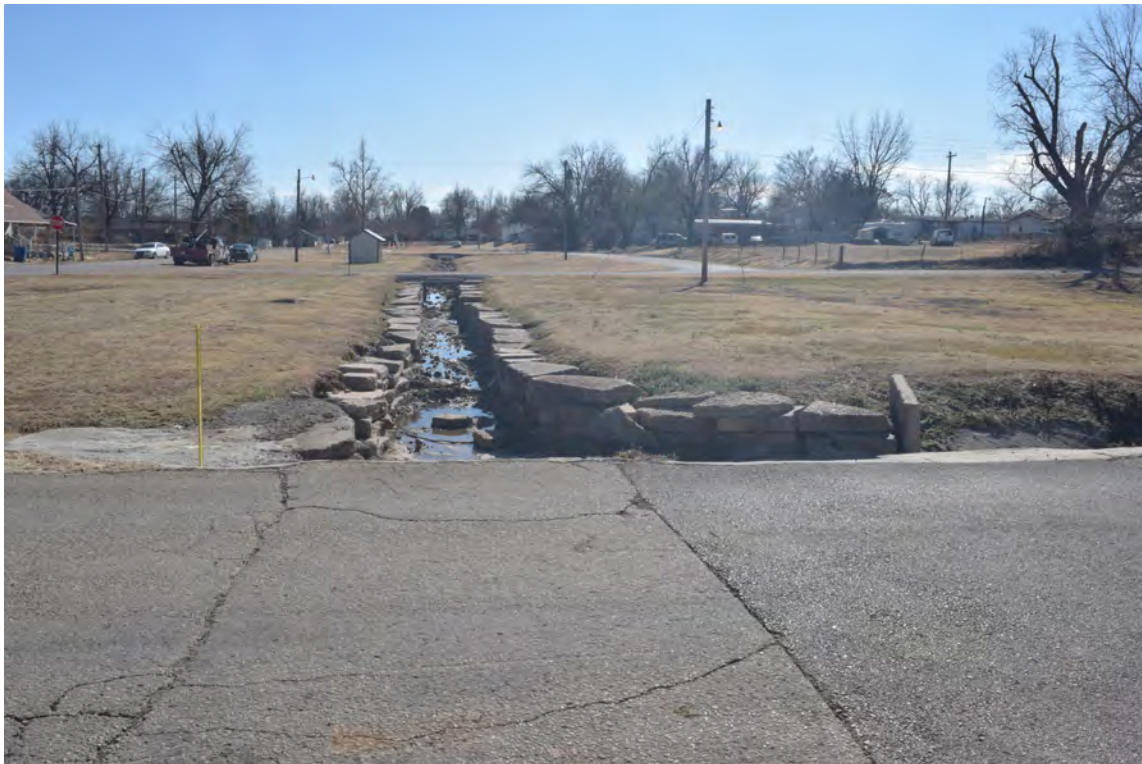
Photo 8: Crossing of waterway at E Oak Street; the section of the canal between E Ash Street and E Oak Street has been fully replaced with piled concrete wedges; view facing south

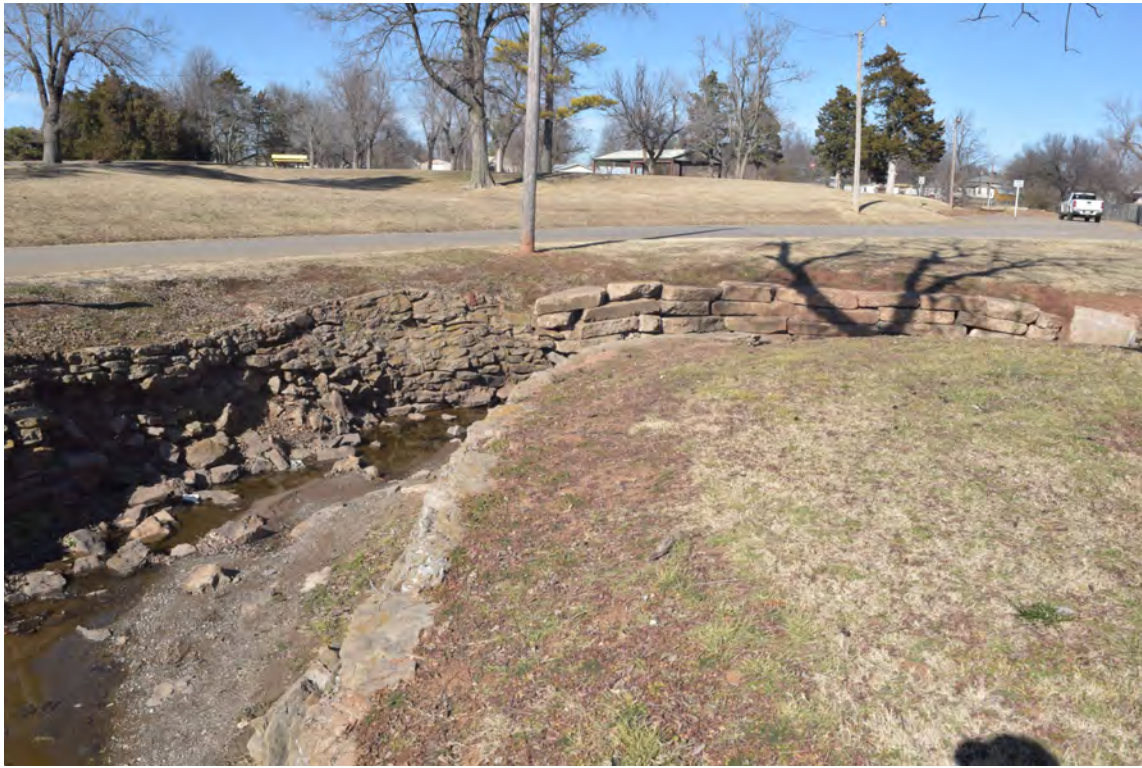
Photo 5: Curve in canal, concrete wedge replacement; view facing north

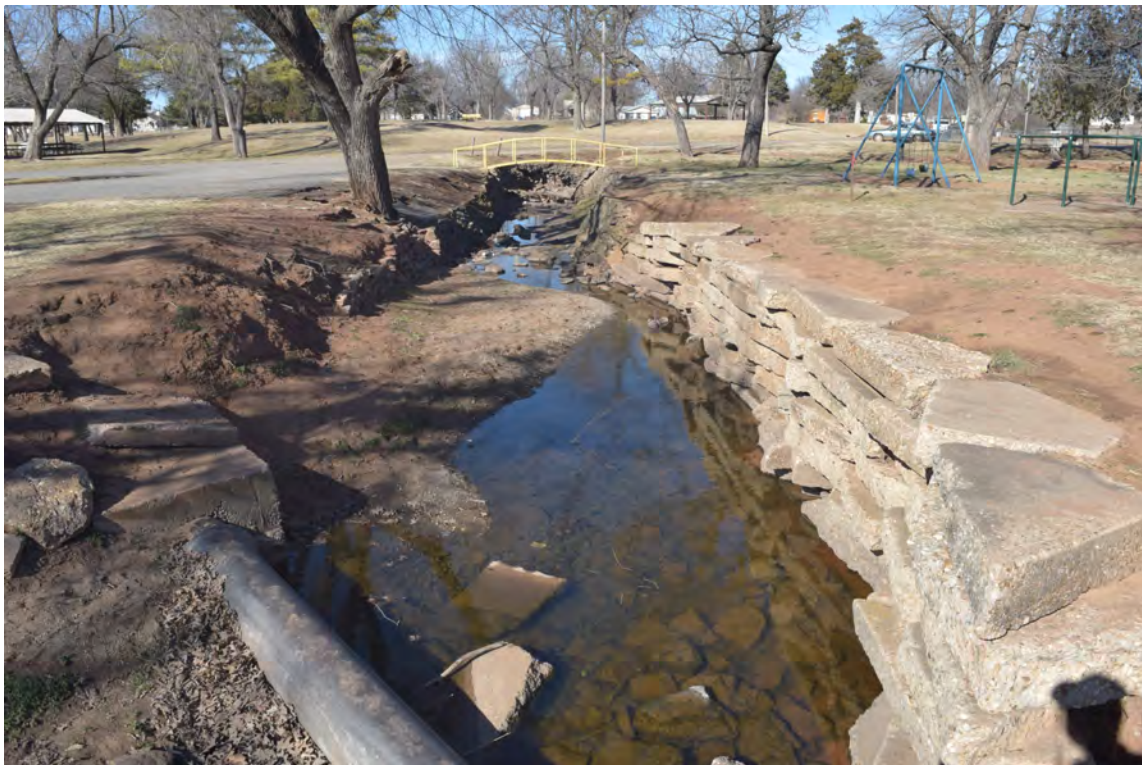
Photo 6: Another curve in canal, concrete wedge replacement material, loss of stonework in evidence, bridge insertion; view facing north

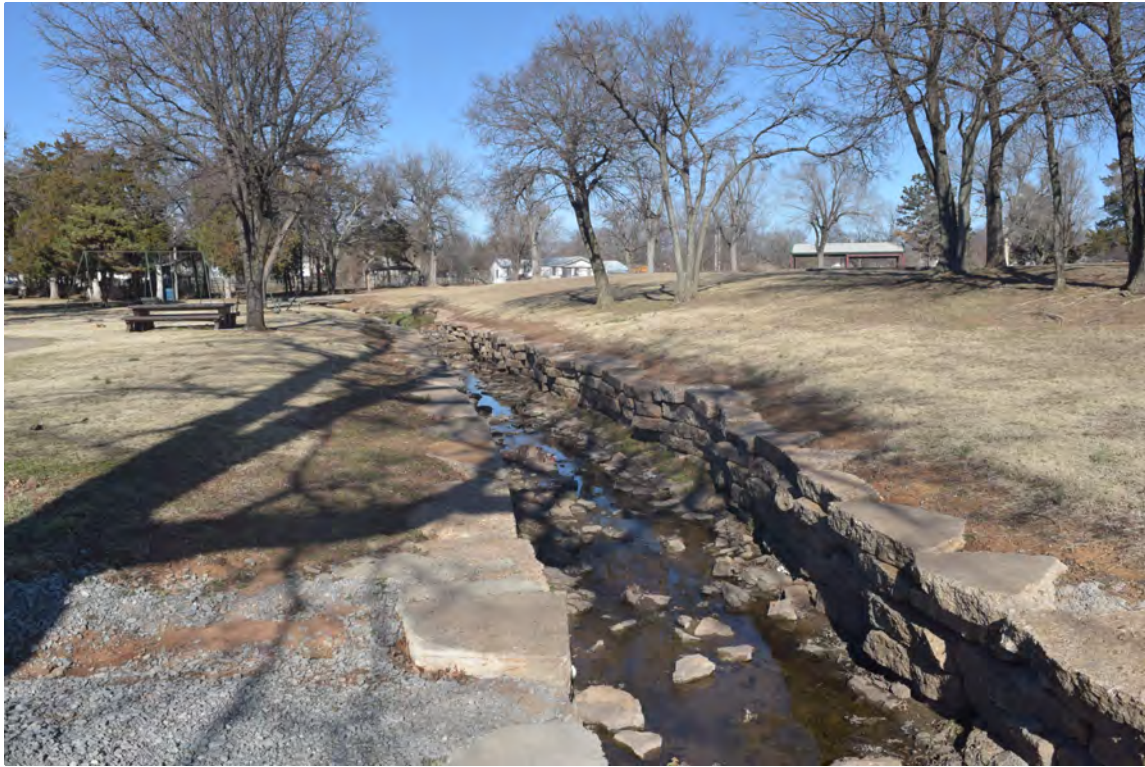
Photo 7: Section of mostly concrete wedge replacement, approximately the middle of Memorial Park; view facing north

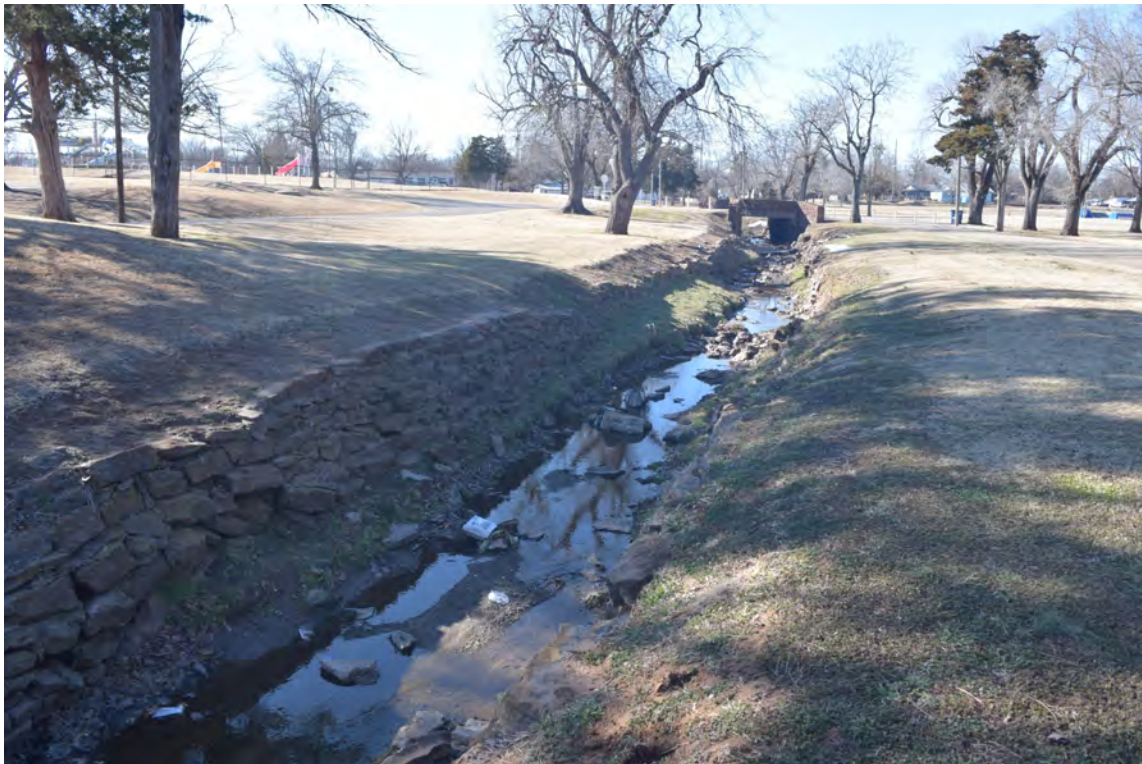
Photo 8: Section displaying coursed, mortared stonework (left bank) and collapsed, removed stonework (right bank); view facing west

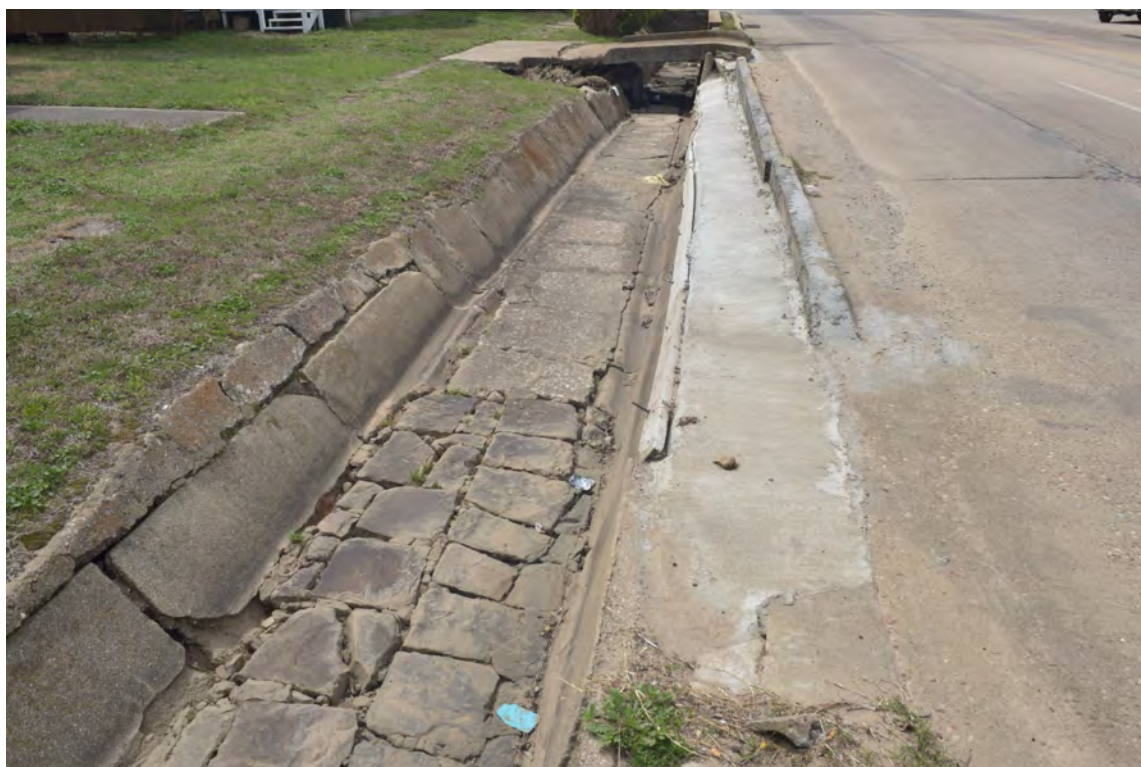
Photo 5: Along N Hinckley St, depicts location of concrete replacement; view facing southwest

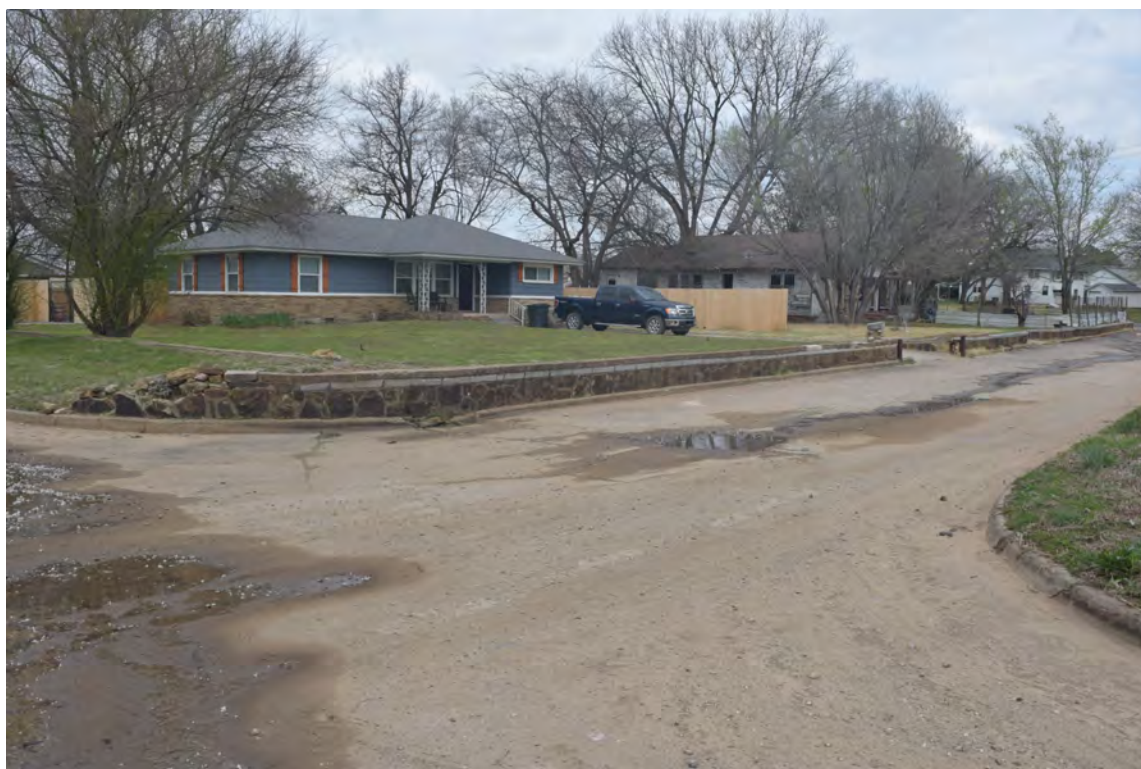
Photo 6: South terminus, west of E 15th Ave, along N Burns St; stonework wall may date to WPA period, no canal evident; view facing north
