16 PRESERVATION BRIEFS

The Use of Substitute Materials on Historic Building Exteriors

National Park Service
U.S. Department of the Interior
Technical Preservation Services

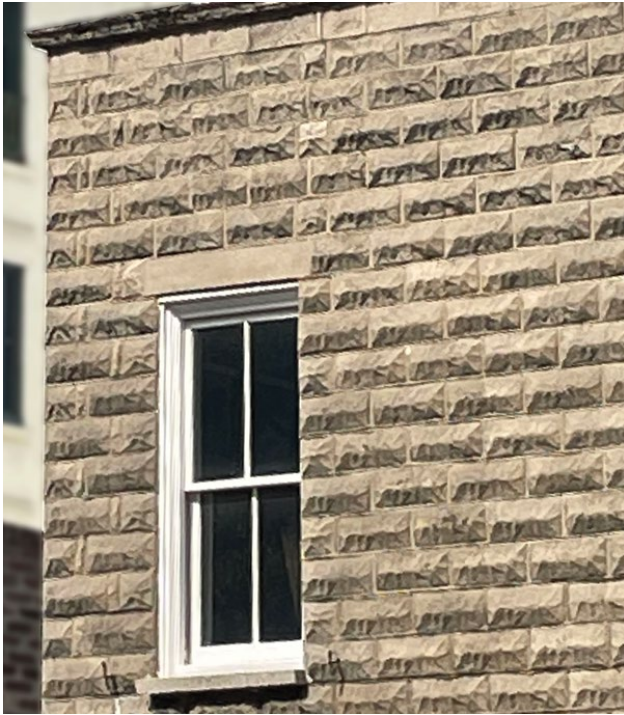
Figure 2a: Casting concrete blocks to mimic quarried stone was a popular late 19th- to mid 20th-century technique. Concrete masonry units could be completed by local craftsman, saving time and shipping costs. Photo: John Sandor, NPS.

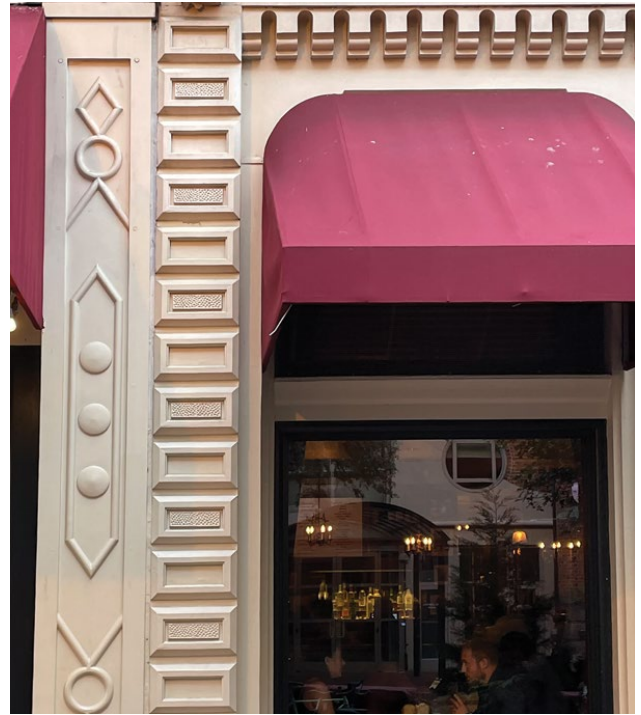
Figure 2b: The 19th century also produced a variety of metal products used to imitate other materials. Across the country, cast iron was used in storefronts to imitate stone. Photo: John Sandor, NPS.

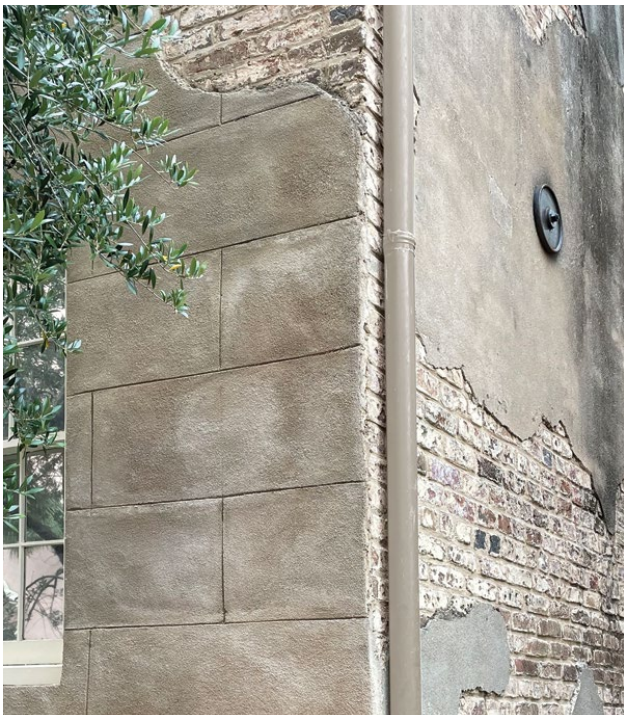
Figure 2c: Stucco has been used to imitate a number of building materials for many centuries. Seen here, stucco was applied to a brick structure and scored to represent a stone façade. Photo: John Sandor, NPS.

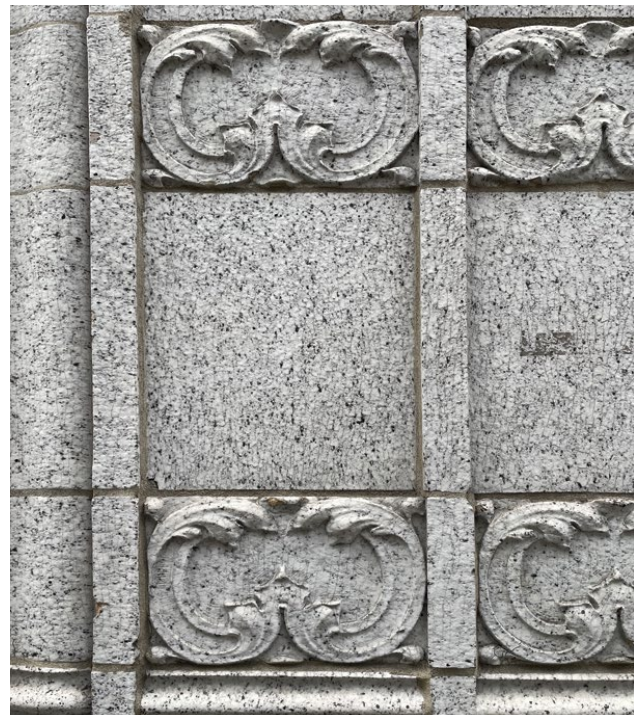
Figure 2d: Terra cotta gained popularity in the late 19th century as a cheap and lightweight alternative to stone. Glazing techniques allowed the blocks to imitate a variety of natural stone materials. Photo: John Sandor, NPS.

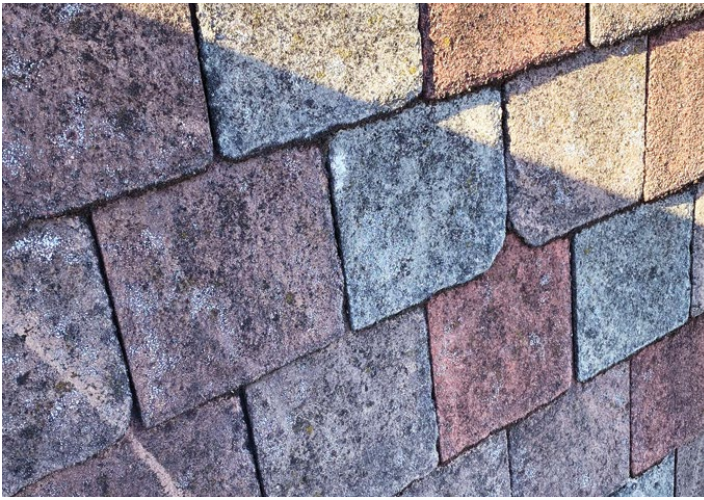
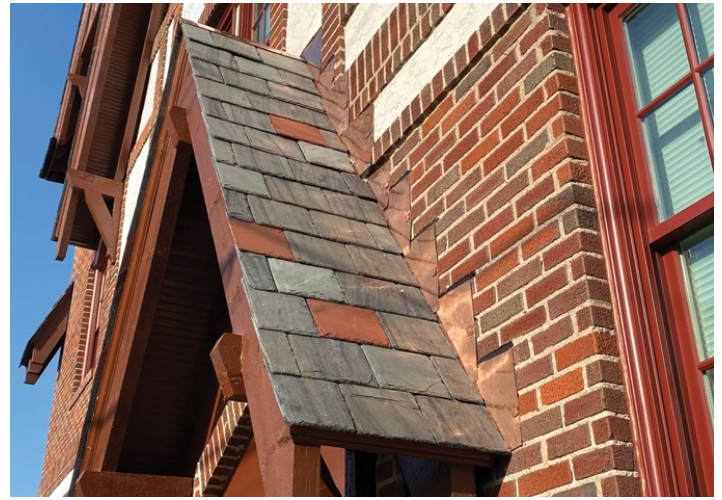
Figure 5. (Left) Asbestos shingles were often used as a substitute for traditional slate roof shingles. The historic asbestos roof on this rehabilitation project had reached the end of its lifespan and required complete replacement. (Right) Given the limited replacement materials available to match the historic asbestos shingles, utilizing natural slate was determined to be the best visual match for the original shingles and design intent in this instance. Photos: Crosskey Architects.

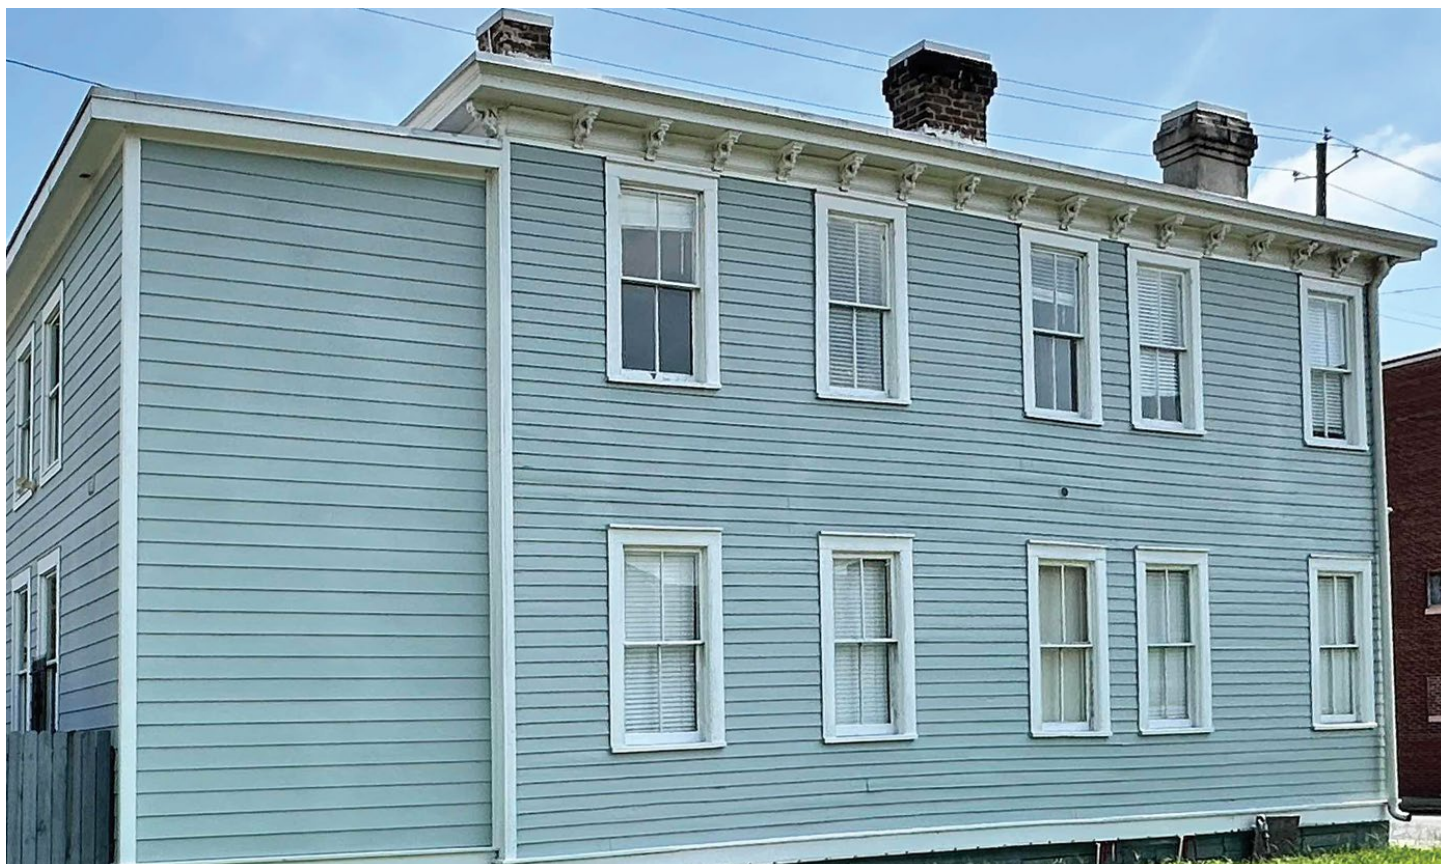
Figure 7. A new addition replaced non-historic construction on the rear elevation of this building. Fiber cement gives the addition a compatible appearance without replicating the exposure for thickness of the historic siding. Photo: Ward Architecture + Preservation.

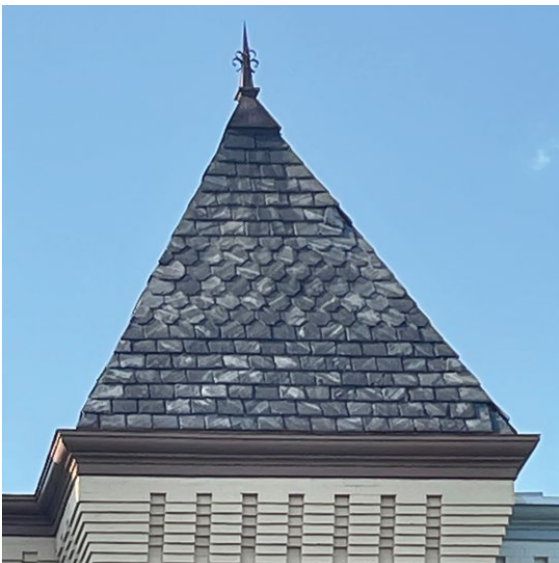
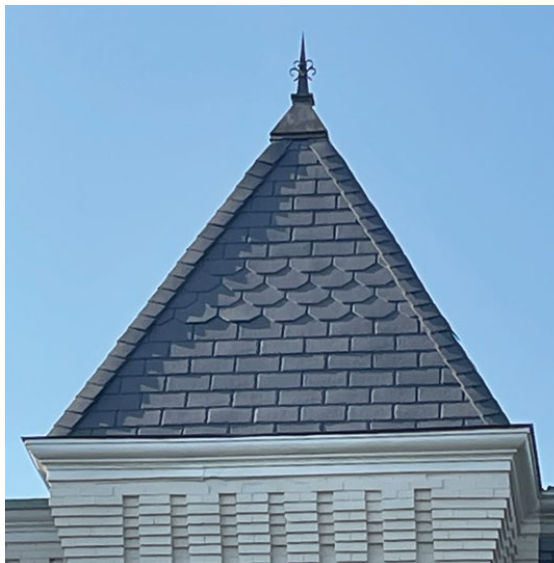
Figure 10a and 10b. Polymer slates offer a choice of shapes but not sizes, limiting their ability to achieve a good visual match for some historic slate. With the size of the polymer slates (Figure 11b) being nearly twice that of the historic slates (11a), the scale of the entire feature is incompatibly altered. The molded edges of this material, which contribute to its ability to replicate slate, would be lost if each shingle was resized by cutting. Photo: John Sandor, NPS.

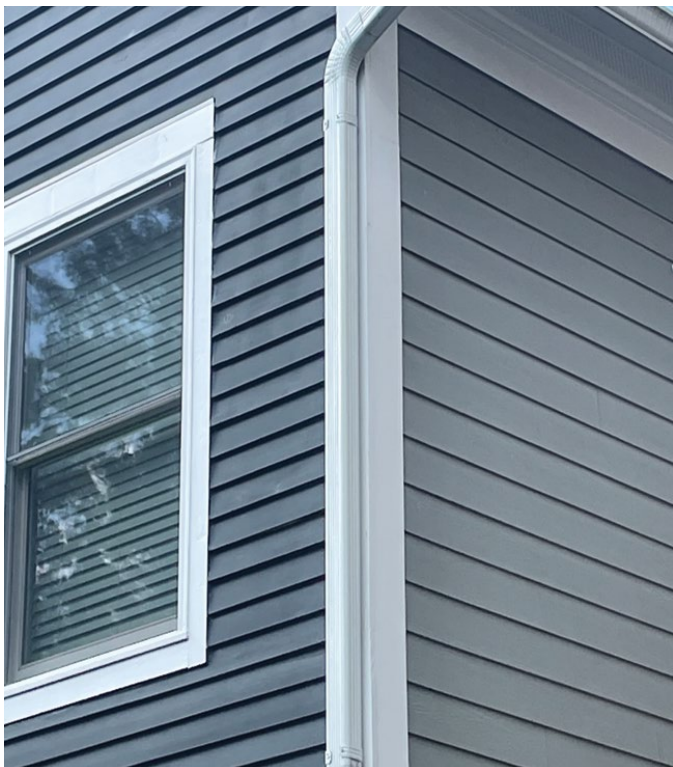
Figure 11. The thickness of the wood siding on the front (left) creates a deeper shadow line than is achieved with the fiber cement siding used on the side (right) elevation. While the exposure can be adjusted, fiber cement siding is not available in a matching thickness. Photo: John Sandor, NPS.

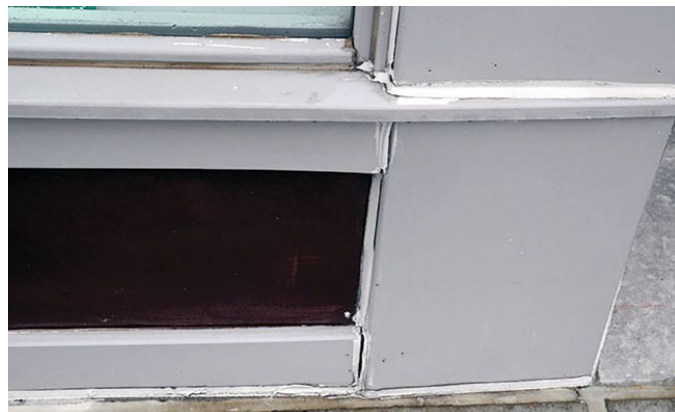
Figure 12. Cellulose composite materials, like wood, expand and contract with moisture. Here it was used to reconstruct a missing storefront. Unlike solid wood that is dimensionally stable parallel to the grain, this composite moves equally in all dimensions, resulting in gaps that were not adequately anticipated in the design. Photo: John Sandor, NPS.

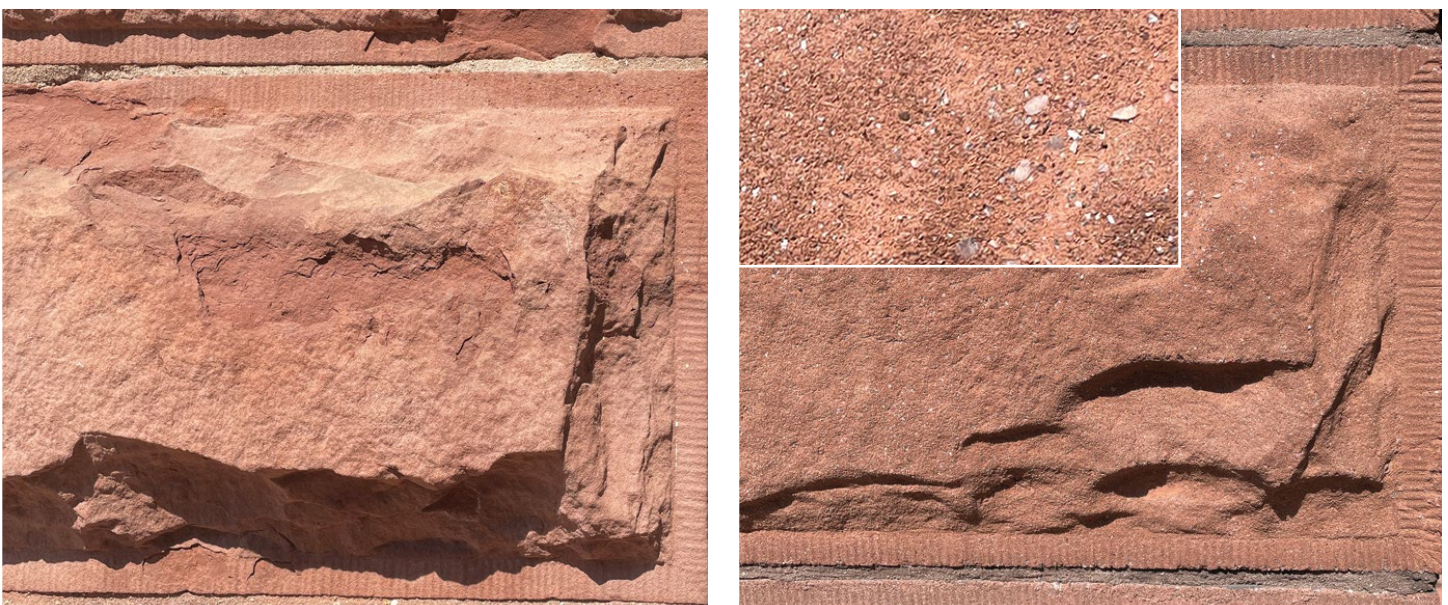
Figure 13. Cast stone was used to effectively replace individual blocks of sandstone. Both the original (left) and the substitute material (right) retain similar physical and visible properties. Having weathered for over 30 years, some erosion of the binder has revealed quartz grains of the aggregate (inset), but it is only noticeable upon close inspection. Photo: John Sandor, NPS.

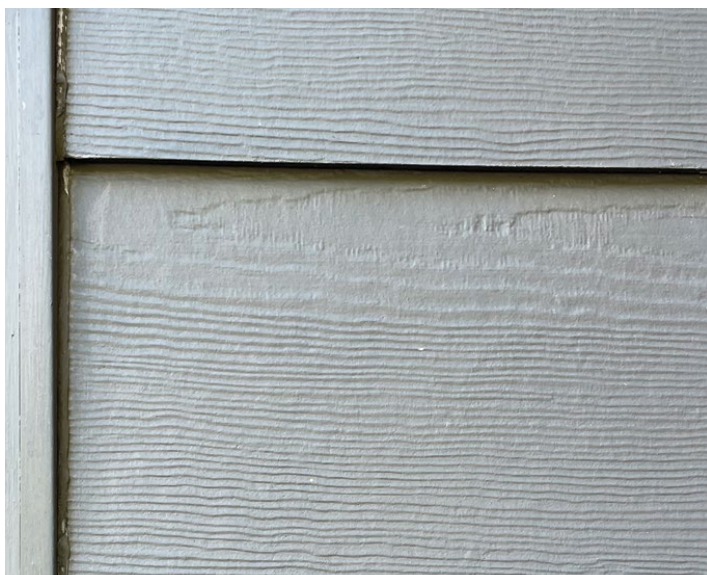
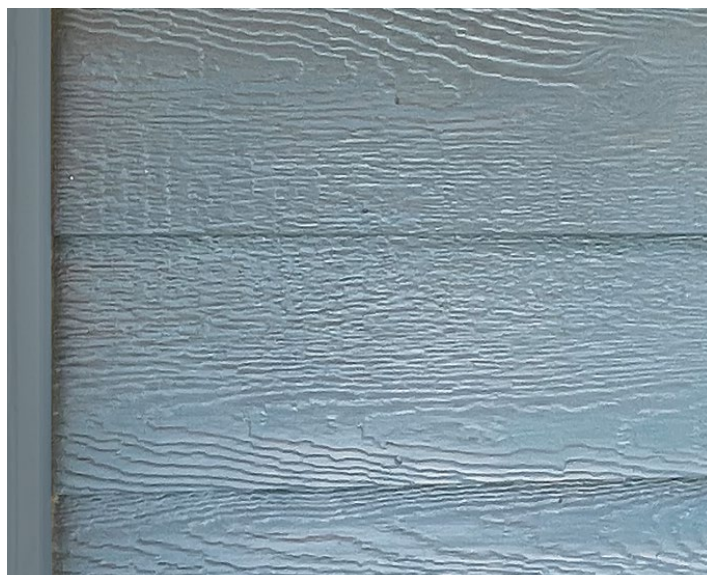
Figure 14. Surface texture is an important aspect in matching the appearance of a historic material, especially when a material is viewed at close range. As seen in these two images, many of the substitute materials produced for siding and trim have an embossed wood grain, making them incompatible for replacing historic wood that was typically planed to a smooth surface. Some substitute products are available with a smooth surface as well. Photos: John Sandor, NPS.

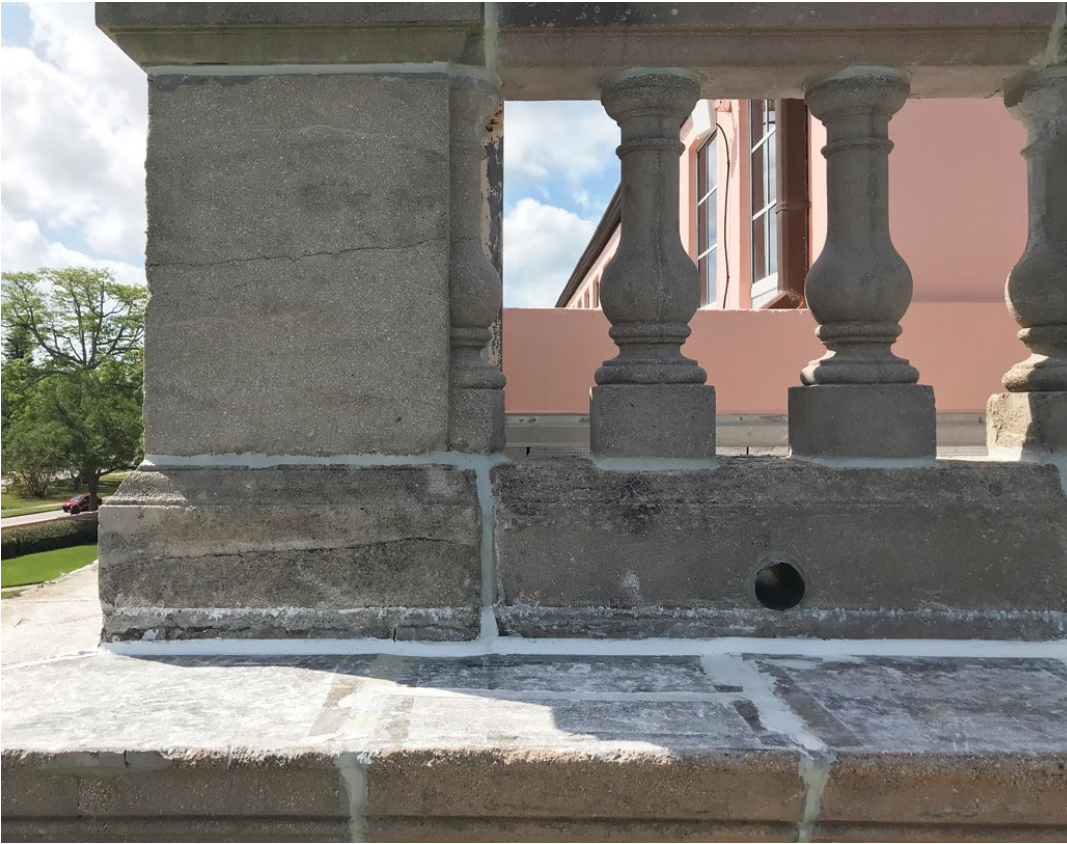
Figure 17. The balustrade consists of multiple prior campaigns of using cast stone to replace the natural stone. The effective match for the surface texture and color of the original stone allowed individual elements to be incrementally replaced only when they had failed, thus retaining the maximum amount of original material as long as possible. Photo: EverGreene Architectural Arts.

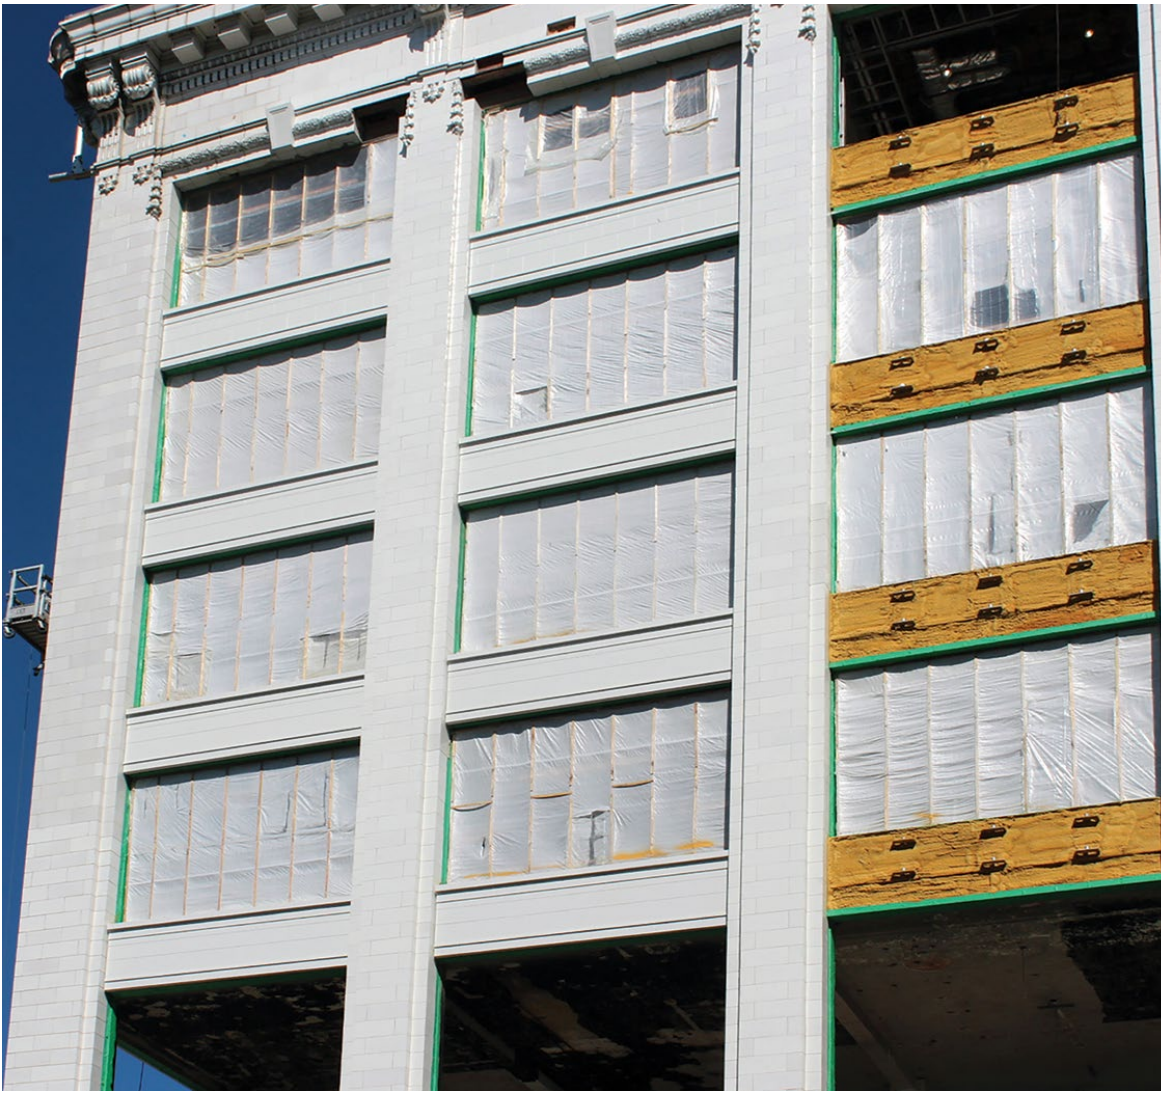
Figure 18. Missing historic terra cotta spandrel panels on all floor levels were recreated utilizing glass fiber reinforced concrete (GFRC) replacements. New spandrels were fabricated as individual components and attached with metal clips between historic terra cotta piers. Photo: Kris Frail, Dewberry.

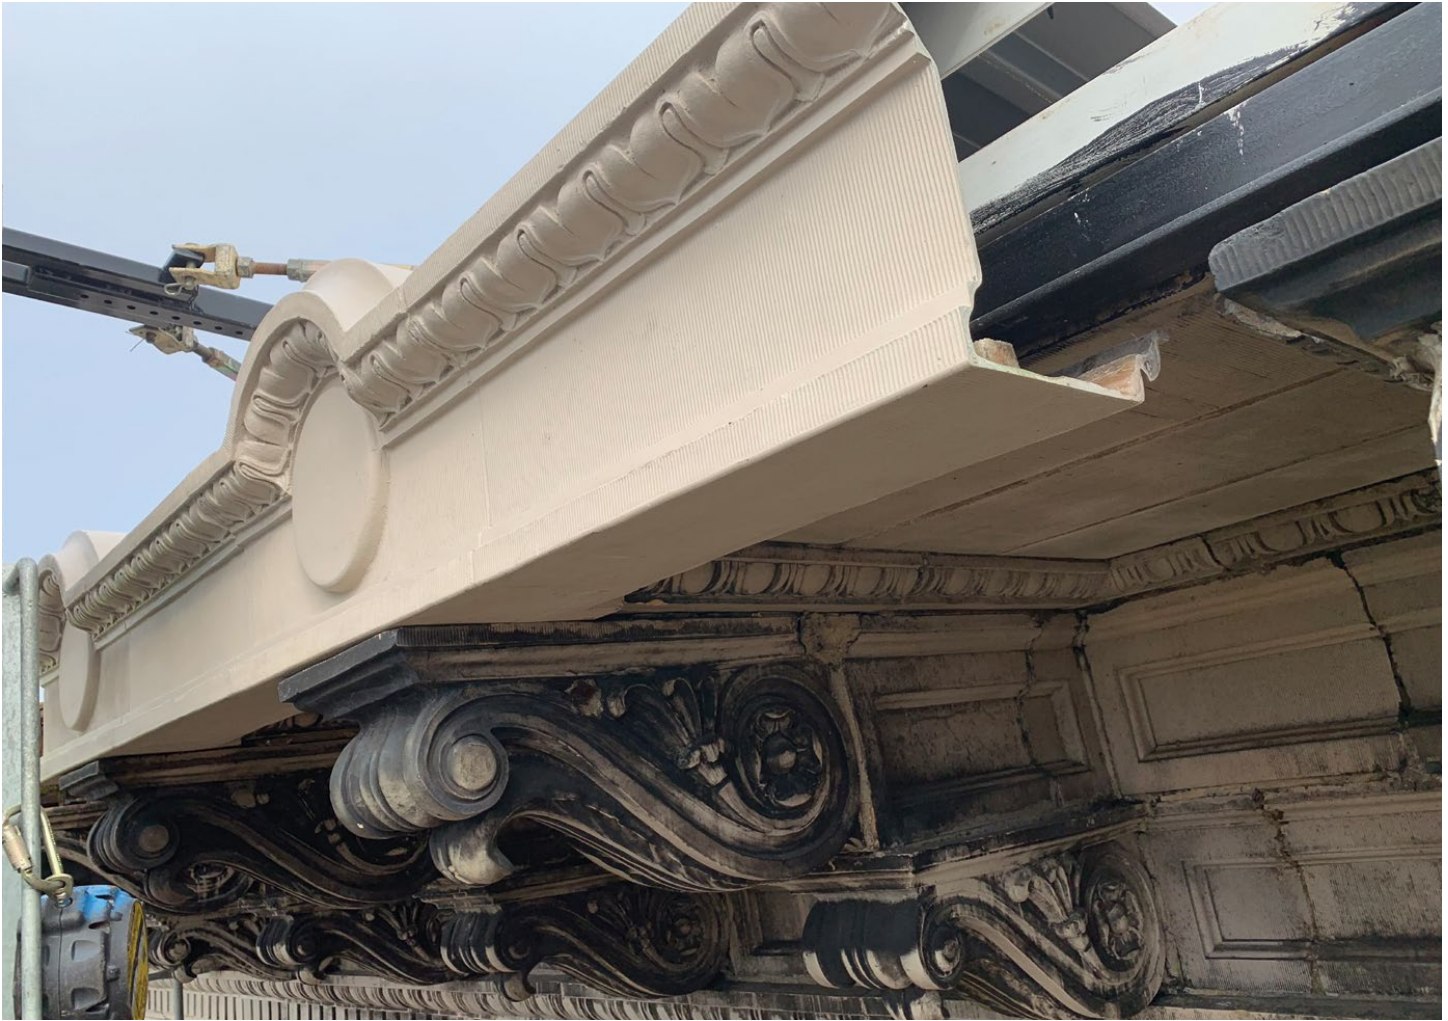
Figure 19. A new, lightweight fiber reinforced polymer is attached to a new metal armature to replicate damaged and missing elements of a terra cotta cornice. Photo: Quinn Evans.

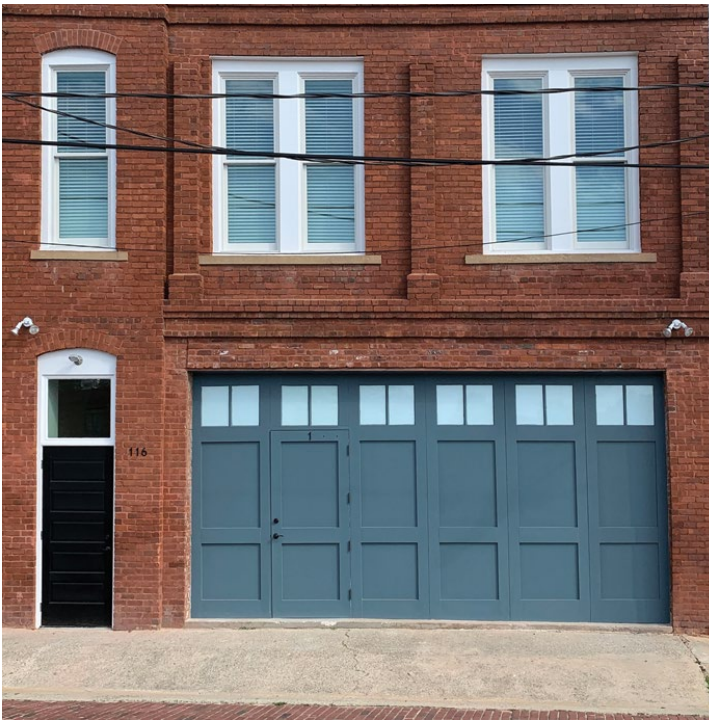
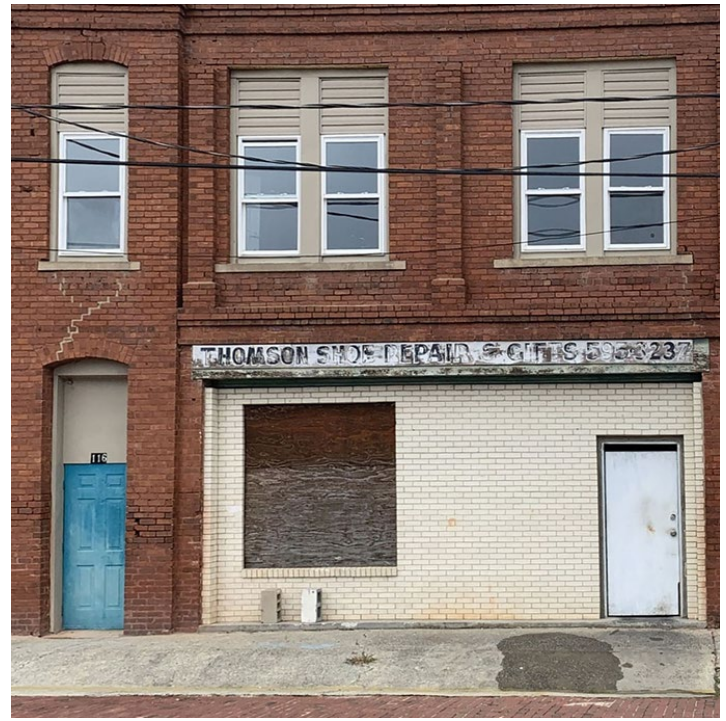
Figure 20. Cement board was used to replace a non-historic infill and mimics the configuration of a typical vehicular door of the period.
Photos: Historic Augusta.

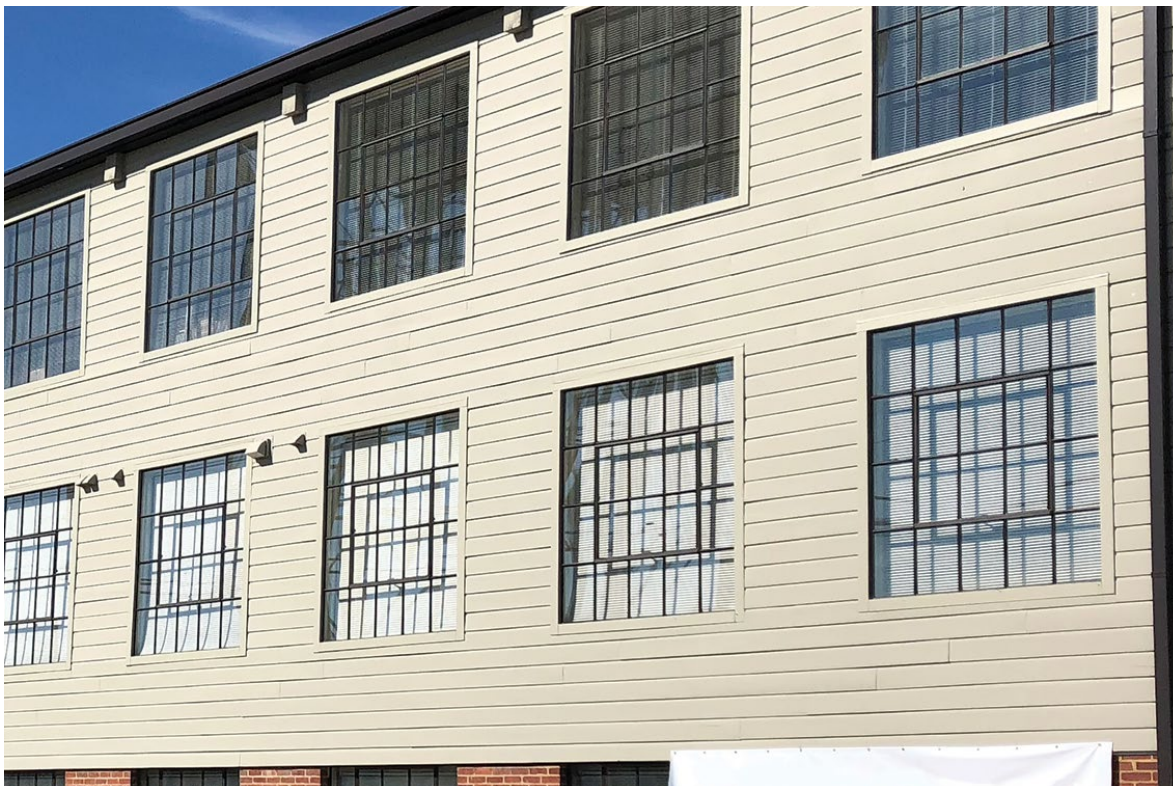
Figure 21. A mineral polymer composite siding was available in the profile very similar to the historic siding. The replacement siding was used where the original material was almost completely missing beneath a more modern covering. Areas where the original wood was largely intact were replaced with matching wood to sustain more of the material integrity of the building. Photo: Belk Architecture.

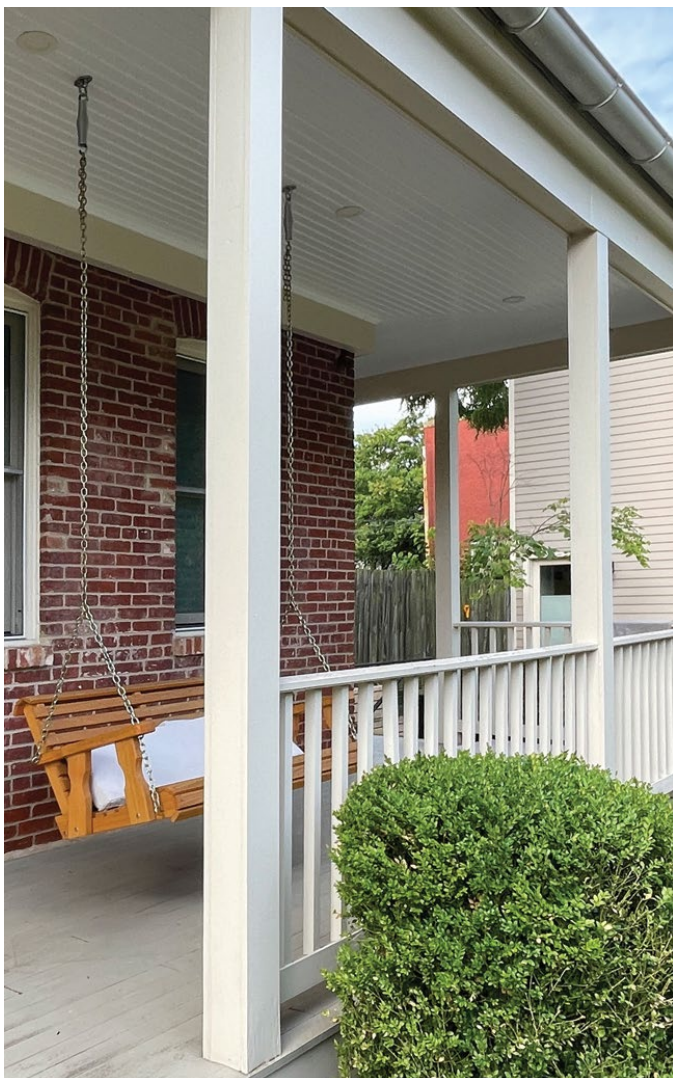
Figure 22. A porch was reconstructed using posts fabricated on site from a smooth-surface cellulose/polymer composite material. Though the face of the posts are painted, the lack of paint on the bottom at the cut ends is not consistent with manufacturers' recommendations. This treatment will allow moisture to be absorbed, shortening the life of the new replacement feature. Photo: John Sandor, NPS.

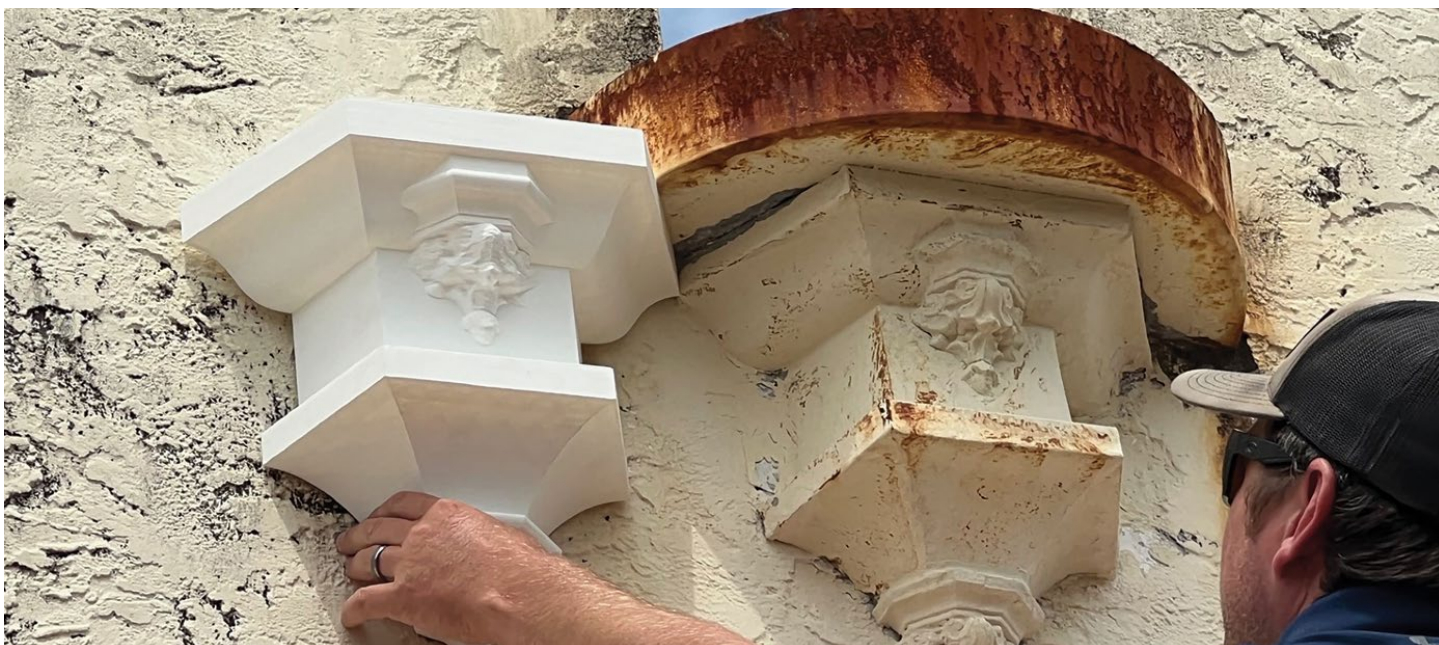
Figure 23. 3-D printing using various polymers is occasionally used to replicate missing metal or wood features. This new application is continually being refined, but the application can be successful when a painted, lightweight feature needs to be replicated. Photo: NPS.

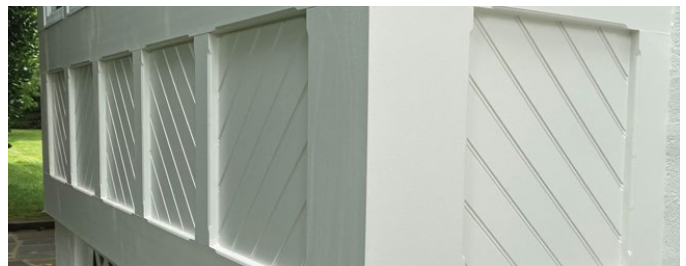
Figure 24. Cellular PVC when painted can be used to replace deteriorated wood features. This beadboard set in a wood frame was not historically designed to shed water effectively and had deteriorated. Cellular PVC was able to match the appearance of the wood details, while its properties were well matched to the shady location, painted finish, and limited size and configuration within the overall assembly; thus, it should provide a long-lasting solution for this application. Photo: Jennifer Balson Alvarez, NPS.
