11 PRESERVATION BRIEFS

Rehabilitating Historic Storefronts

H. Ward Jandl

U.S. Department of the Interior
National Park Service
Cultural Resources
Heritage Preservation Services

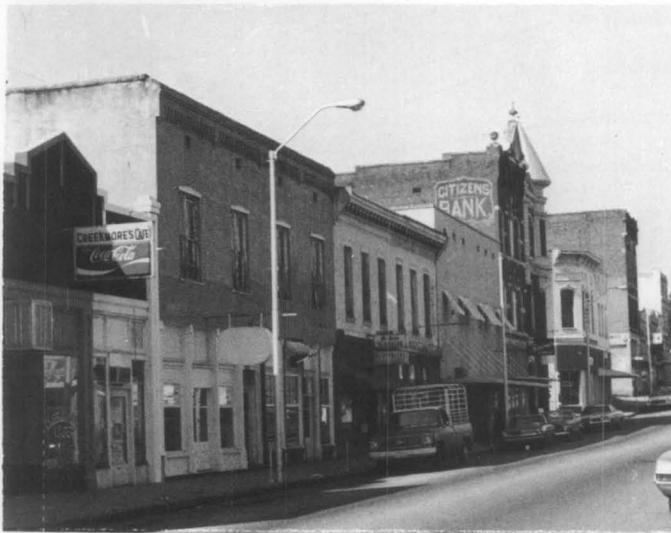
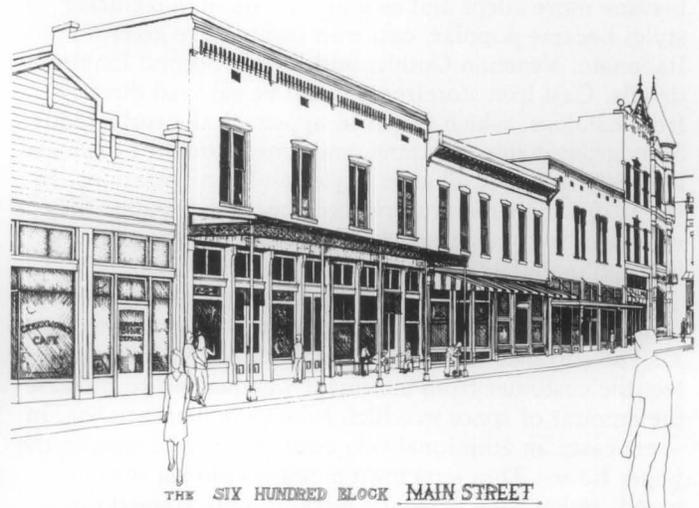
Figure 1. Inappropriate storefront alterations over the years—metal cladding, oversized signs and canopies—have detracted from the character of this historic district in Van Buren, Arkansas. A carefully considered rehabilitation plan for Main Street, including the removal of poorly designed signs, false fronts and the selection of an appropriate exterior paint color palette, serves to enhance the visual environment and preserves the district's sense of time and place. Photo above: Bob Dunn; Drawing, David Fitts

As more and more people come to recognize and appreciate the architectural heritage of America's downtowns, however, a growing interest can be seen in preserving the historic character of commercial buildings. The sensitive rehabilitation of storefronts can result not only in increased business for the owner but can also provide evidence that downtown revitalization efforts are succeeding (see figure 1).

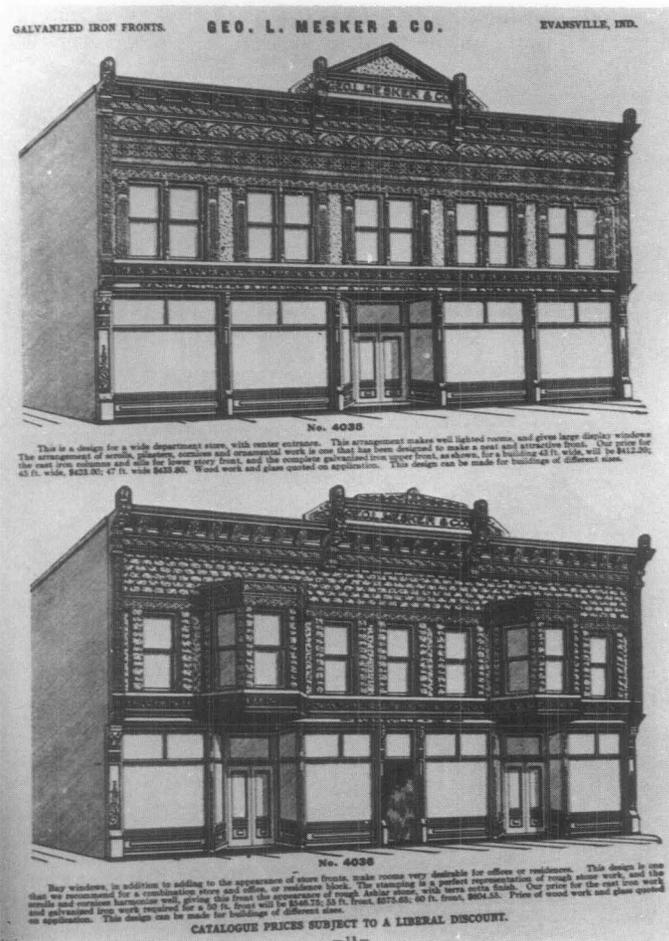
Figure 2. These 19th century galvanized iron storefronts could be purchased from George L. Mesker & Co. in Evansville, Indiana.

The first cast iron fronts were simple post-and-lintel construction with little decoration. As iron craftsmen became more adept and as more ornate architectural styles became popular, cast iron fronts were given Italianate, Venetian Gothic, and French Second Empire details. Cast iron storefronts could be selected directly from catalogs, which began to appear in the early 1850's. Standardized sills, columns, and lintels could be arranged to create fronts of all sizes, styles and configurations. In the 1870's sheet metal storefronts became popular; they were also sold in standardized sizes and configurations through manufacturers' catalogs (see figure 2).

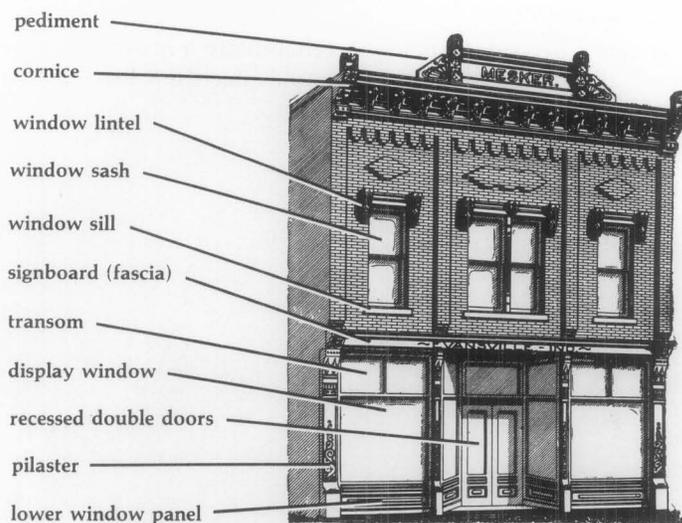
Figure 3. Become familiar with the architectural features typical of historic commercial buildings. A close look at a storefront's construction materials, features and relationship to the upper stories will help in determining how much of the original facade remains.

This particular storefront is No. 4016 in the George L. Mesker and Company catalog of 1905. One of Mesker's most popular designs, it featured cast-iron sills, columns and lintels, galvanized iron lintel and main cornice, window caps and pediment.

The typical 19th century storefront consisted of single or double doors flanked by display windows (see figure 3). The entrance was frequently recessed, not only to protect the customer from inclement weather but to increase the amount of space in which to display merchandise. In some cases an additional side door provided access to the upper floors. Thin structural members of cast iron or wood, rather than masonry piers, usually framed the storefront. The windows themselves were raised off the ground by wood, cast iron or pressed metal panels or bulkheads; frequently, a transom or series of transoms (consisting of single or multiple panes of glass) were

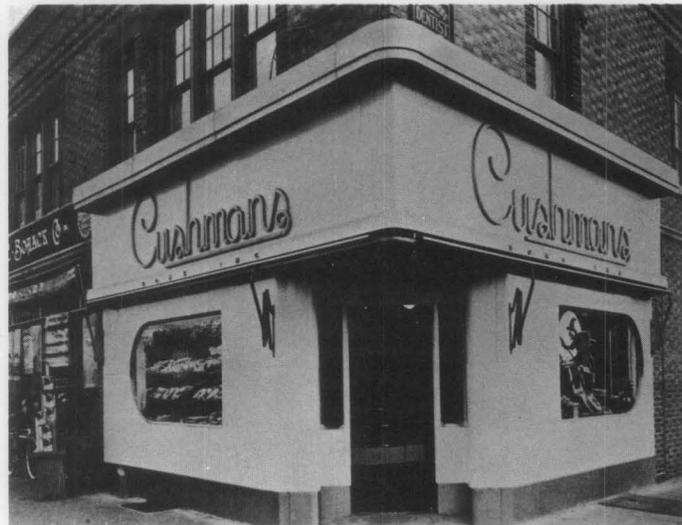
Figure 4. This storefront in New York City designed by Raymond Loewy typifies the streamlined look of the 1930's. Added to an earlier building, the front utilizes glass, stainless steel and neon to make a modern statement. This is a good example of a later storefront which has acquired significance and should be retained in any rehabilitation.

The first decades of the 20th century saw the growing use of decorative transom lights (often using small prismatic glass panes) above display windows; in some cases, these transoms could be opened to permit air circulation into the store. Electric incandescent lights enabled storeowners to call attention to their entrance and display windows and permitted nighttime shopping. In the 1920's and 1930's a variety of new materials were introduced into the storefront, including aluminum and stainless steel framing elements, pigmented structural glass (in a wide variety of colors), tinted and mirrored glass, glass block and neon. A bewildering number of proprietary products also appeared during this period, many of which went into storefronts including Aklo, Vitrolux, Vitrolite, and Extrudalite. Highly colored and heavily patterned marble was a popular material for the more expensive storefronts of this period. Many experiments were made with recessed entries, floating display islands, and curved glass. The utilization of neon lighting further transformed store signs into elaborate flashing and blinking creations. During this period design elements were simplified and streamlined; transom and signboard were often combined. Signs utilized typefaces for the period, including such stylized lettering as "Broadway," "Fino" and "Monogram." Larger buildings of this period, such as department stores, sometimes had fixed metal canopies, with lighting and signs as an integral component of the fascia (see figure 4).

In evaluating whether the existing storefront is worthy of preservation, recognize that good design can exist in any period; a storefront added in 1930 may have greater architectural merit than what is replaced (see figure 4). In commercial historic districts, it is often the diversity of

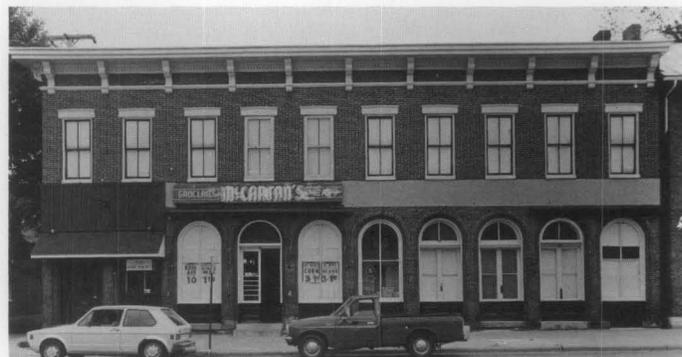
Figure 5. In some cases, as in the storefront on the extreme left, it is a simple matter to determine original appearance by looking at neighboring storefronts. Removal of the board and batten fasciabord, pent roof, and "colonial" style door, all of which could be undertaken at minimal cost, would restore the original proportions and lines of the building. Photo: Day Johnston

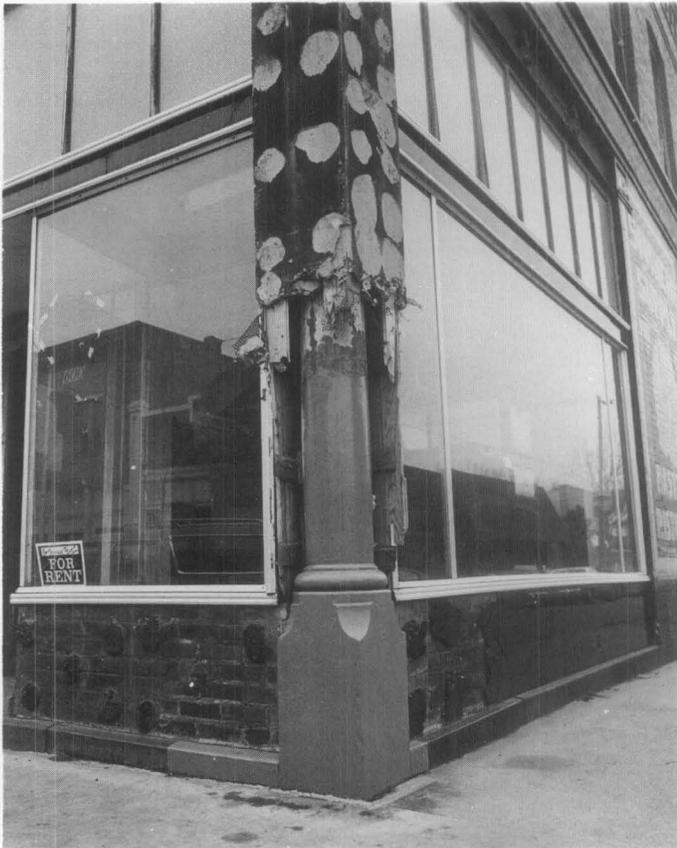
Figure 6. Storefronts of the 1940's, 50's, and 60's were frequently installed by attaching studs or a metal grid over an early front and applying new covering materials. If the existing storefront is a relatively recent addition with little or no architectural merit, begin by removing the covering materials in several places as was done here. If this preliminary investigation reveals evidence of an earlier front, such as this cast-iron column, carefully remove the later materials to assess the overall condition of the historic storefront. The black mastic visible on the lower masonry panels was used for installing pigmented structural glass. Some attachment methods for modern facings, such as mastic or metal lath, may have seriously damaged the original fabric of the building, and this must be taken into account in the rehabilitation process. Photo: Bob Dunn

tent and nature of rehabilitation work needed (see figure 6). In most cases, this examination is best undertaken by a qualified professional.

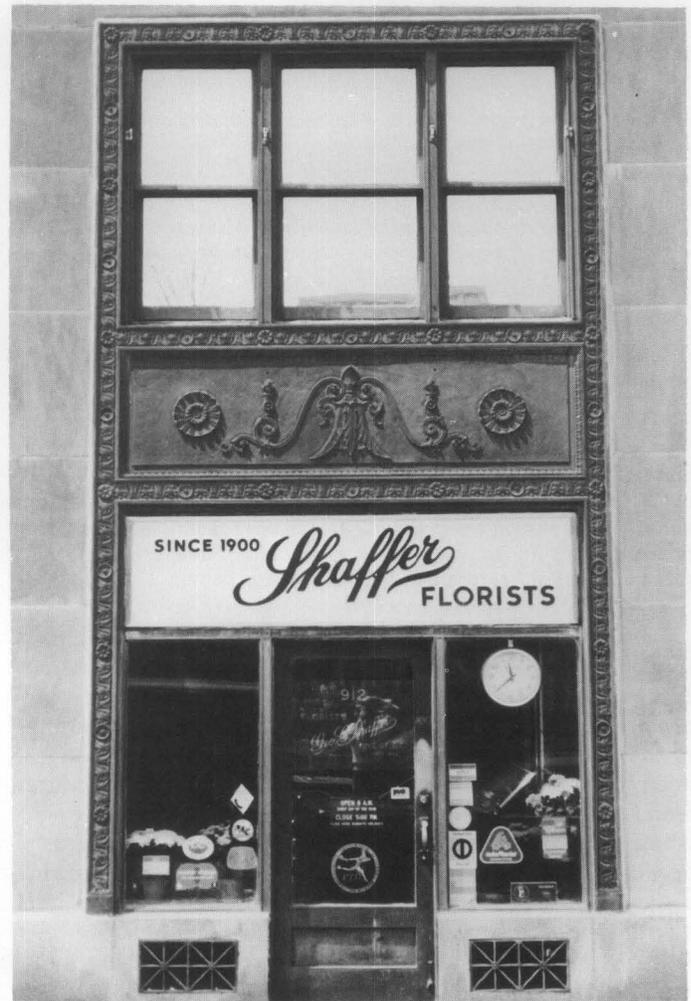
Figure 7. Part of a large office building constructed in Washington, D.C. in 1928, this finely detailed bronze storefront is typical of many constructed during this period. It should be noted that the original grilles, spandrel panel and window above are all intact. Photo: David W. Look, AIA

Bronze and brass—nonmagnetic, abrasive-resistant alloys combining copper with varying amounts of zinc, lead, or tin. These copper alloys, more commonly found in office buildings or large department stores, range in color from lemon yellow to golden brown to green depending on their composition and are well suited for casting (see figure 7).

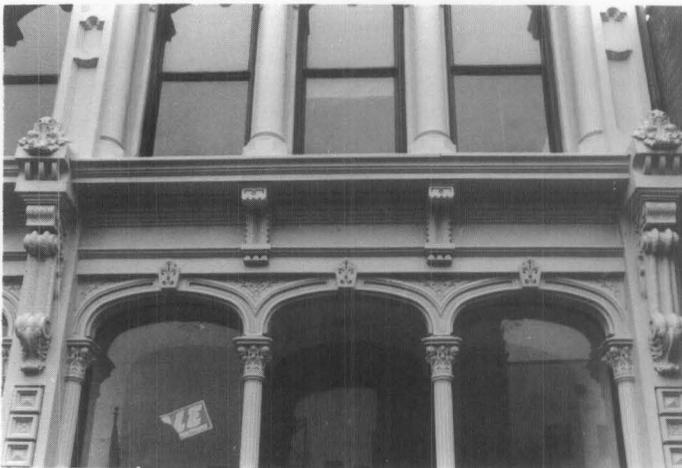
Figure 8. When the Grand Opera House in Wilmington, Delaware, was rehabilitated, missing cast-iron columns were cast of aluminum to match the original; in this particular case, because these columns do not carry great loads, aluminum proved to be successful substitute. Photo: John G. Waite

If metal components have deteriorated to a point where they have actually failed (or are missing), replacement is the only reasonable course of action. If the components are significant to the overall design of the storefront, they should be carefully removed and substituted with components that match the original in material, size and detailing (see figure 8).

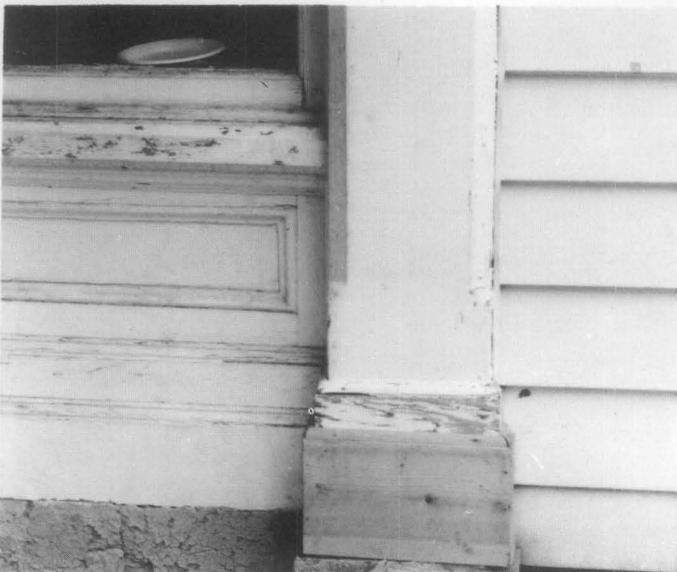
Figure 9. Rather than replace an entire wooden storefront when there is only localized deterioration, a new wooden component can be pieced-in, as seen here in this column base. The new wood will need to be given primer and top coats of a high quality exterior paint—either an oil-base or latex system. Also wood that is flaking and peeling should be scraped and hand-sanded prior to repainting. Photo: H. Ward Jandl

Where components of wood storefronts are so badly deteriorated that they cannot be stabilized, it is possible to replace the deteriorated parts with new pieces (see figure 9). These techniques all require skill and some expense, but are recommended in cases where decorative elements, such as brackets or pilasters, are involved. In some cases, missing edges can be filled and rebuilt using wood putty or epoxy compounds. When the epoxy cures, it can be sanded smooth and painted to achieve a durable and waterproof repair.

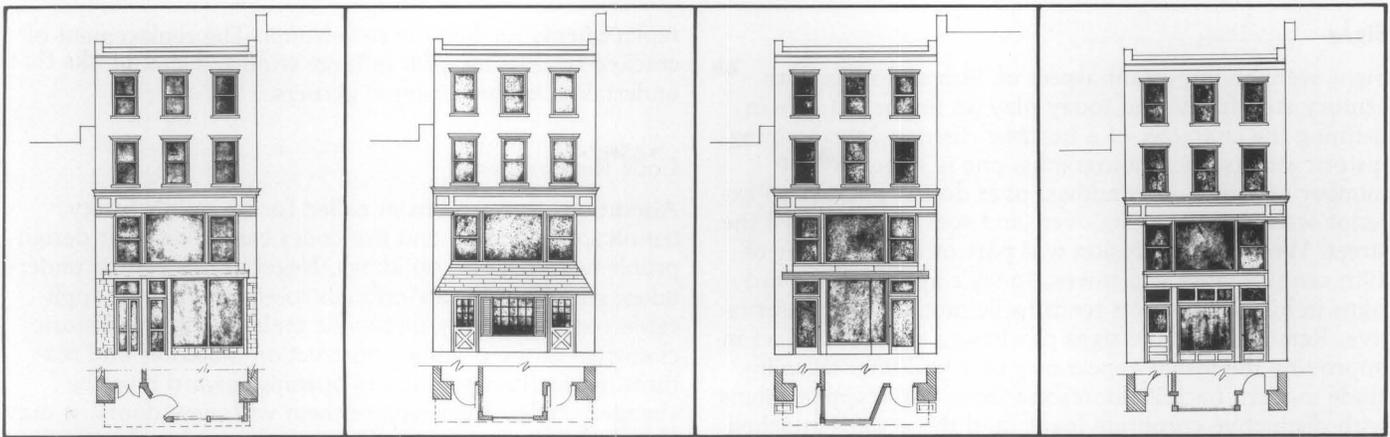
Figure 10. (A) This existing storefront, added in the 1950's to a late 19th century brick building, extends beyond the plane of the facade; faced with anodized aluminum and permastone, it does not contribute to the architectural and historic character of the building. (B) This replacement design uses "lumberyard colonial" detailing, such as barn-type doors, shutters, small paned windows, and a wood shake pent roof. The design, detailing, and choice of materials are clearly inappropriate to this commercial building. (C) This replacement design retains the 1950's projecting canopy but symmetrical placement of the doors relates well to the second floor windows above; this contemporary design is compatible with the scale and character of the building. (D) This replacement design accurately restores the original appearance of the building; based on historical research and physical evidence, it too is an acceptable preservation approach. Drawings: Sharon C. Park, AIA

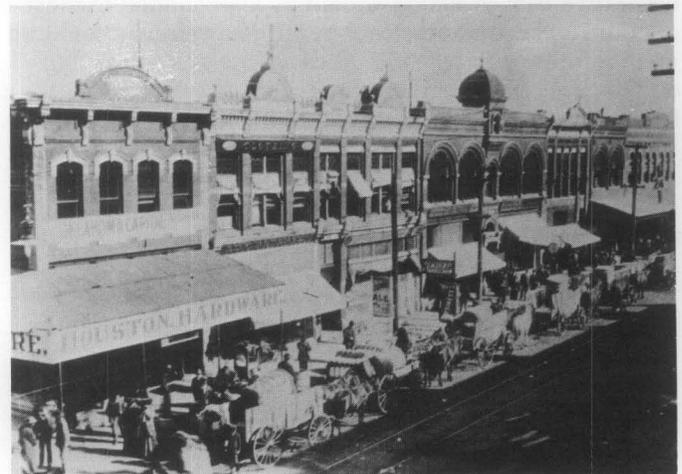
Figure 11. Try to locate old photographs or prints to determine what alterations have been made to the storefront and when they were undertaken. Awnings were common elements of storefronts at the turn of the century. They can be equally useful today.

Where based on historic precedent, consider the use of canvas awnings on historic storefronts (see figure 11).

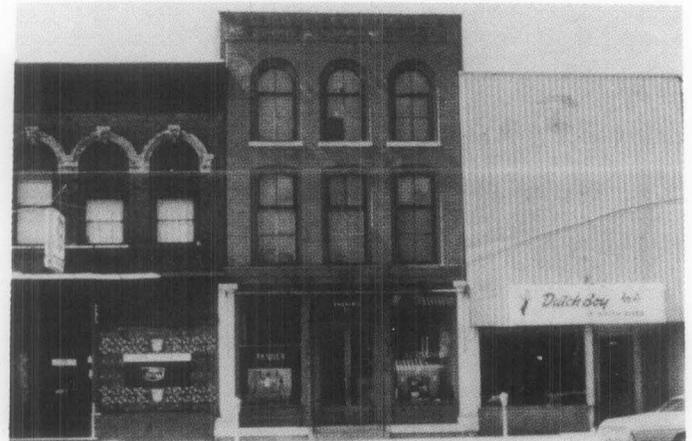
Figure 12. This photograph of three late 19th century commercial buildings clearly shows the impact of preserving and rehabilitating storefronts. The one on the right has been totally obscured by a "modern" front added in the 1950's. Although inappropriate alterations have taken place on the left storefront, it is still possible to determine the original configuration of the doors and display windows. The storefront in the middle has remained intact. Although in need of some minor maintenance work, the appeal of the original design and materials is immediately apparent.

A key to the successful rehabilitation of historic commercial buildings is the sensitive treatment of the first floor itself (see figure 12). Wherever possible, significant storefronts (be they original or later alterations), including windows, sash, doors, transoms, signs and decorative features, should be repaired in order to retain the historic character of the building. Where original or early storefronts no longer exist or are too deteriorated to save, the commercial character of the building should nonetheless be preserved—either through an accurate restoration based on historic research and physical evidence or a contemporary design which is compatible with the scale, design, materials, color and texture of the historic building. The sensitive rehabilitation of historic storefronts will not only enhance the architectural character of the overall building but will contribute to rejuvenating neighborhoods or business districts as well.
